A Success Story in District 6 – Shaver Lake Maintenance Facility

This bulletin recounts a storm water management success story about the Shaver Lake Maintenance Facility in District 6. Not only do the efforts of Shaver Lake management and staff deserve recognition, their creative solutions for achieving water pollution control compliance at their facility should be shared for everyone's benefit.

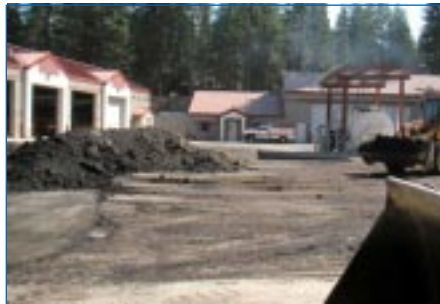
First, asphalt stockpiles were located at the center of the facility. Vehicles driving over the stockpiles broke the material down and tracked it across the facility so that it was near impossible to preventing contact and transporting materials off the facility with storm water runoff.

Before: Tracked asphalt and other materials could be easily transported off the facility in storm water.

- A more focused self-inspection and cleaning program that addressed problem areas.
- Regular sweeping and/or vacuuming of facility grounds to remove accumulated pollutants per Section 2.29 – Sweeping and Vacuuming.
- Implementation of sediment and erosion controls, such as straw mats, silt fence, and fiber rolls on slopes to stabilize soil and control sediment, per Section 2.7 – Sediment Control.
- Asphalt paving in dirt areas with high potential for erosion.
- Increase in communication and education of facility staff on proper Best Management Practices (BMPs).

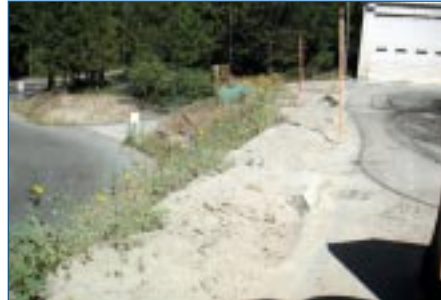
Second, the unpaved areas of the facility were not stabilized to prevent erosion. Wind and storm water can transport eroded soils to storm drains, rivers, and lakes resulting in increased sediment loads that reduce natural habitat quality.

Before: Stockpile material and eroded sediment from unstabilized slopes can affect habitat quality, particularly in pristine areas such as the Sierra Nevada mountains.

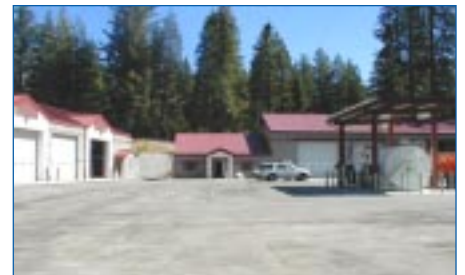
After: A clean facility with minimal potential for pollutant discharges.

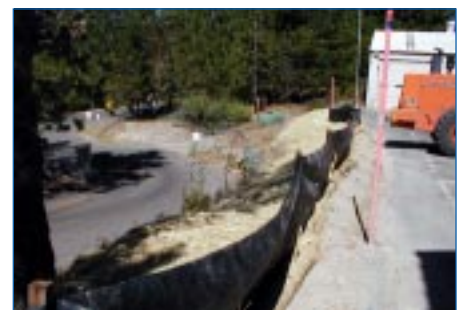
After: Stabilized slopes are an effective tool for preventing sediment from discharging off site.
